PLAY AREA SAFETY INSPECTION REPORT

For Deopham and Hackford PC

On 17th June 2024

Play Area, Vicarage Road, Deopham

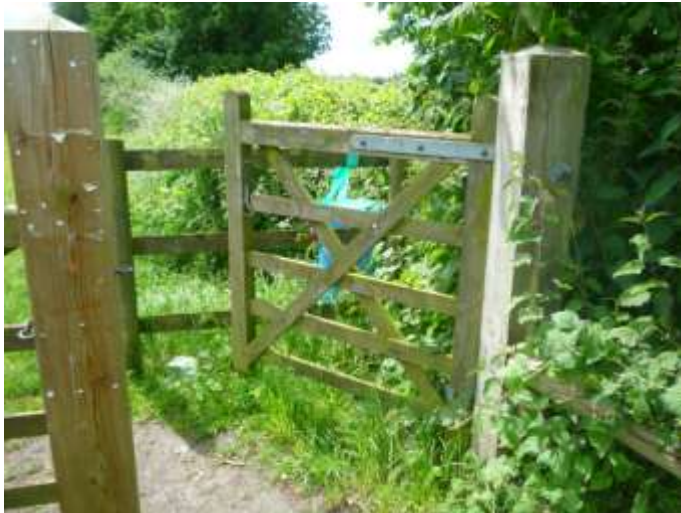
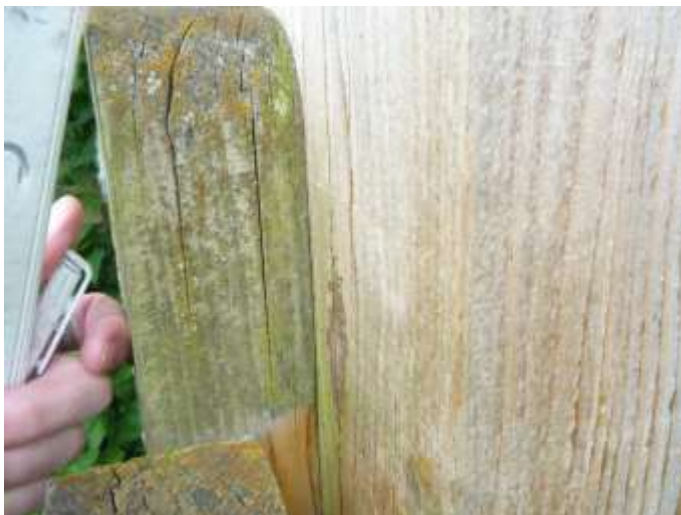
Pedestrian Gate x 1 - Crushing and Shearing Points on the side(s) of gate. Recommend to adjust gate/fit new rubber buffer to ensure a spacing of at least 12mm throughout the range of the gate to remove the hazard. The 12mm gap should also apply on the hinge side of the gate – Low to Medium risk.

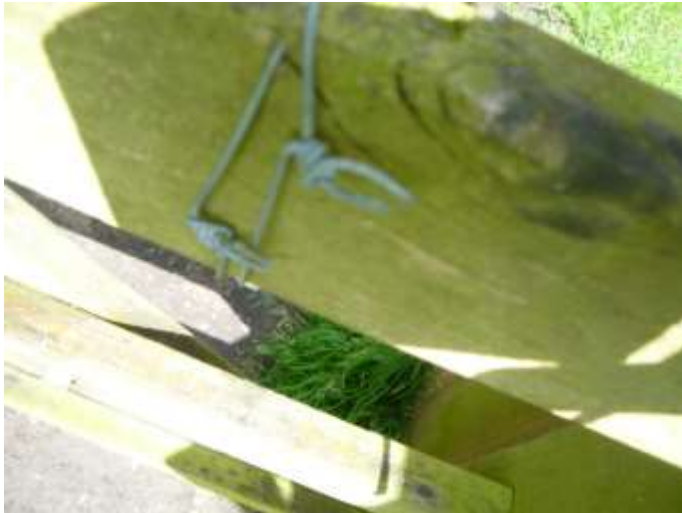
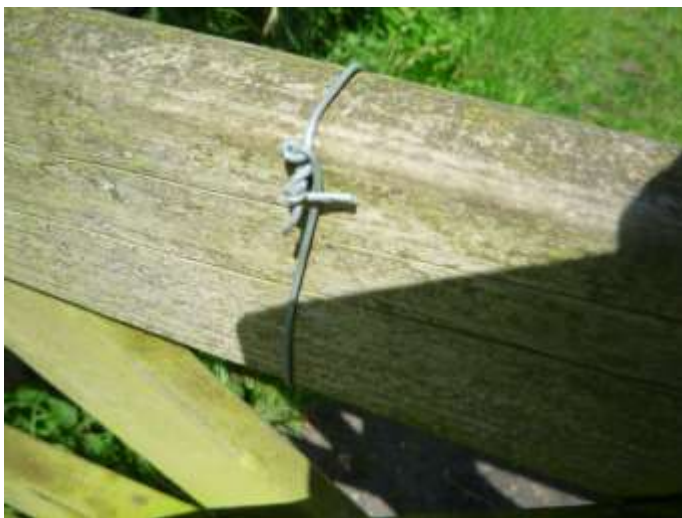
Recommend remove barbed wire – on gate - Low to Medium risk.

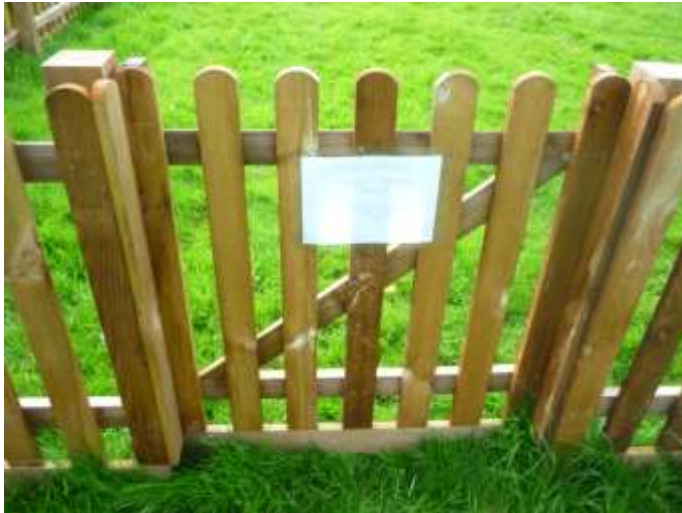
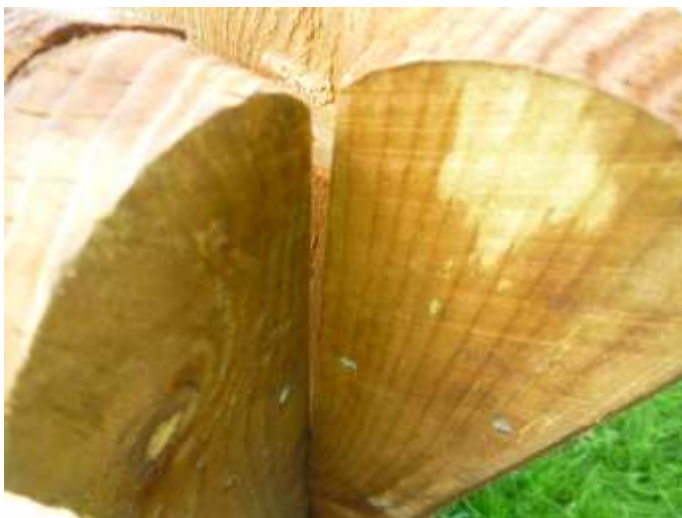
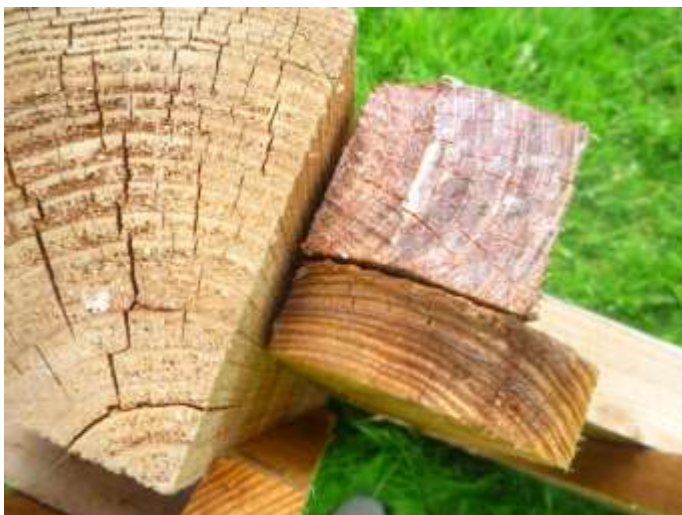
Play Area Pedestrian Gate - Gate x 1 - Crushing and Shearing Points on the side(s) of gate. Recommend to adjust gate/post/fit new rubber buffer to ensure a spacing of at least 12mm throughout the range of the gate to remove the hazard. The 12mm gap should also apply on the hinge side of the gate - Medium risk.

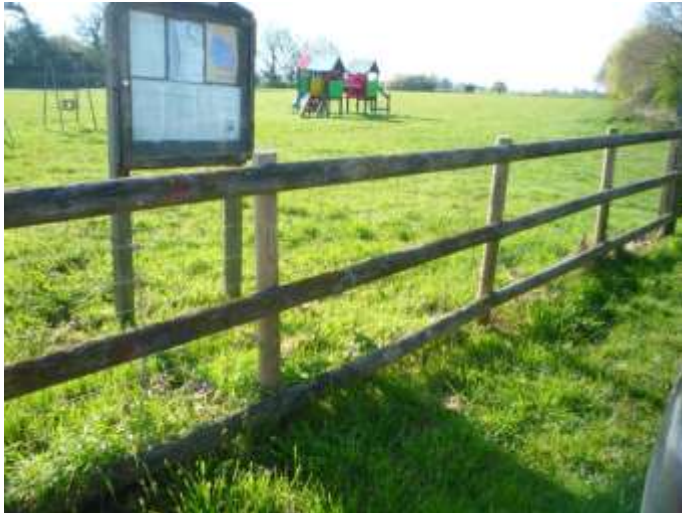
Fence – Stock fences that can be climbed are not recommended for play areas, however due to the rural location and the large amount of fencing, it should be accepted and only monitor – Low risk.

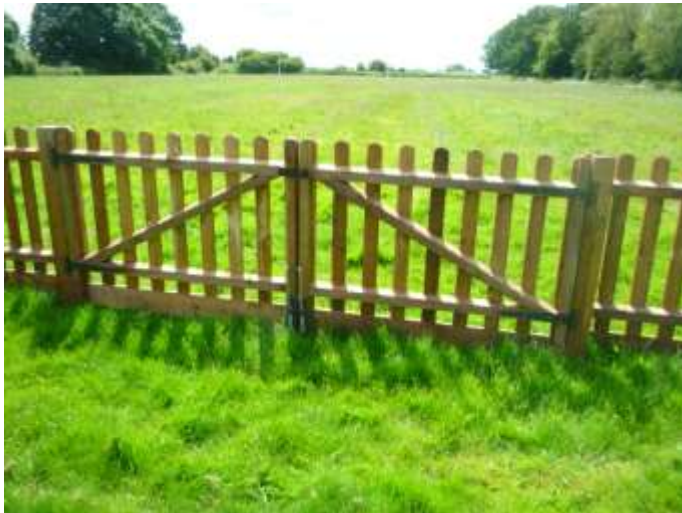
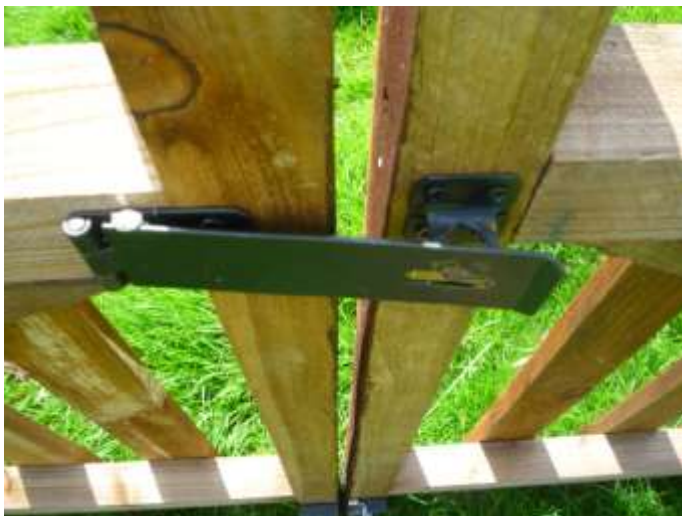
Maintenance Gate – Recommend adjust gate catch so that a lock can be put onto gate - Low risk.

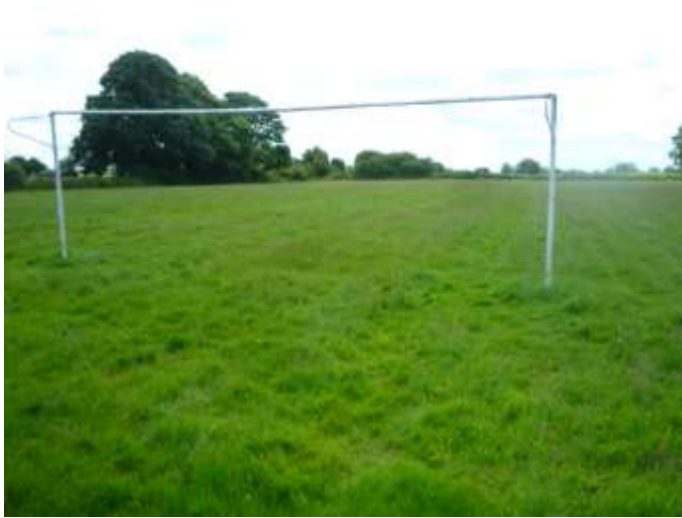
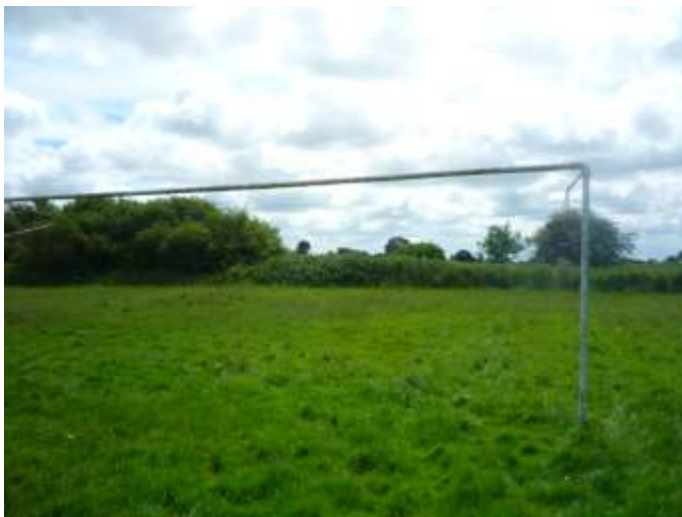
Item: Informal Football Goals x 2

The item meets the requirements of EN1176 where this may be tested on site without dismantling or destruction.

Recommend rub down and remove rust and flaking paint, which has rough and sharp areas - and repaint to prolong life of item - Low risk.

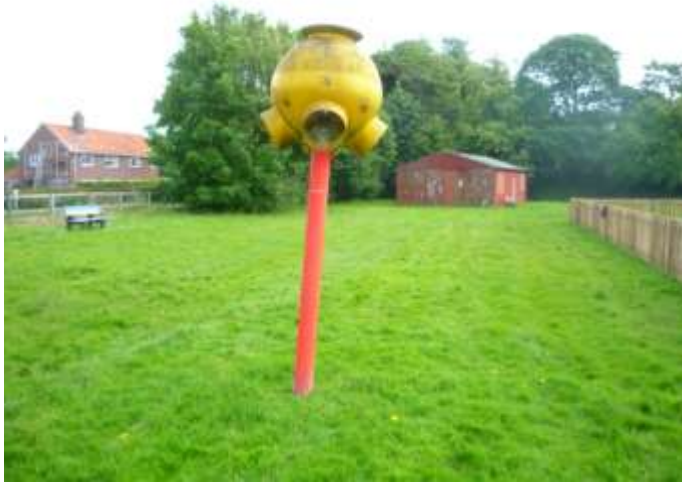
Item: Ball Shoot (2006-7) – Wicksteed Leisure

The item meets the requirements of EN1176 where this may be tested on site without dismantling or destruction.

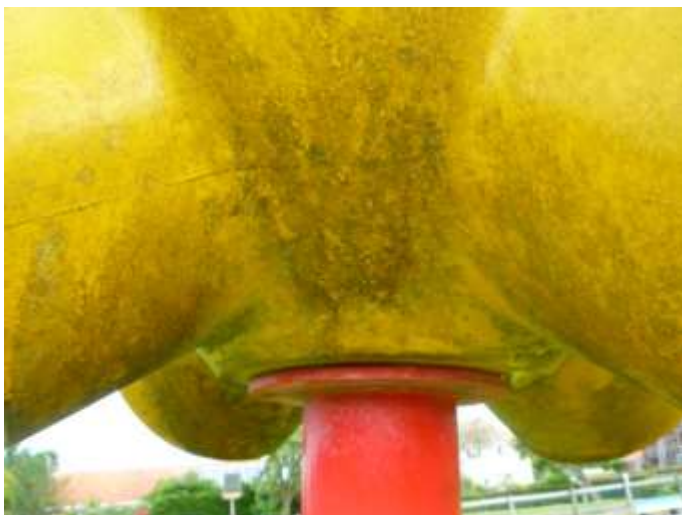
Recommend clean off dirt and algae - Low risk.

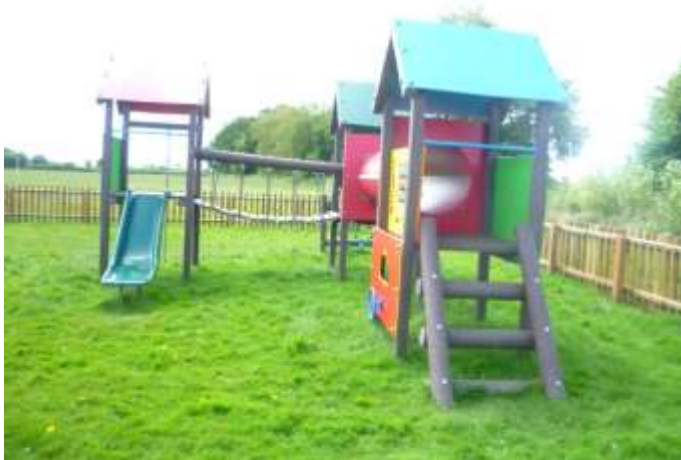
Item: Multiplay – Play Quest

The item meets the requirements of EN1176 where this may be tested on site without dismantling or destruction.

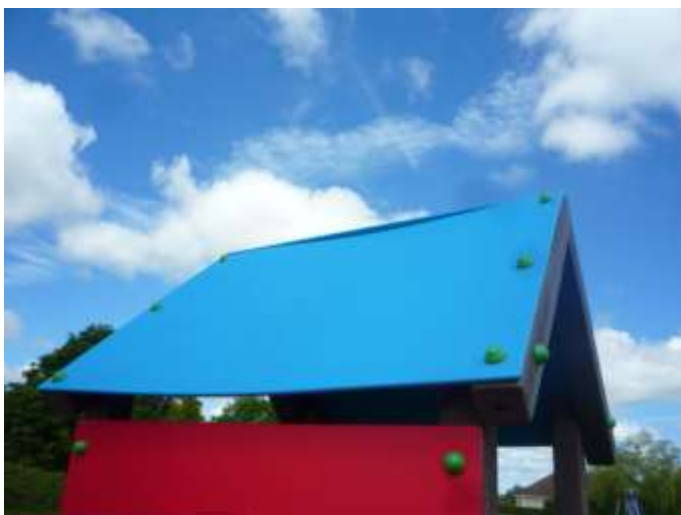
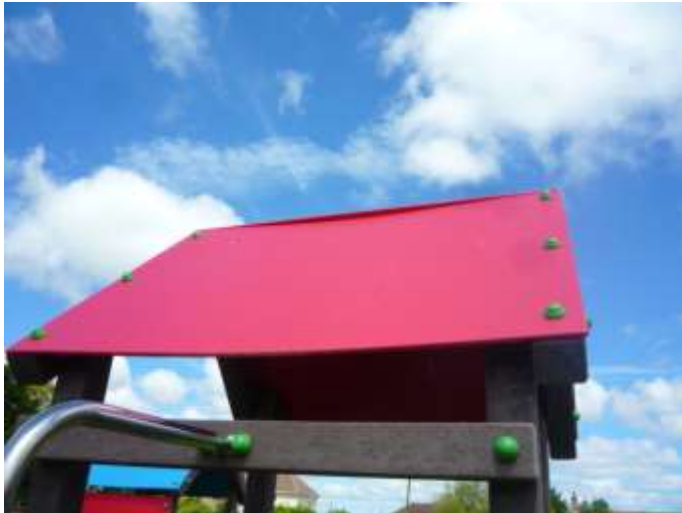
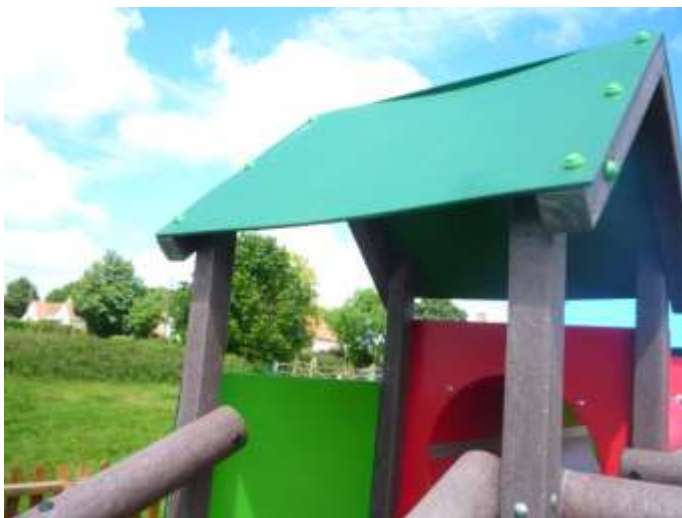
Recommend monitor slight warping of the roof panels - No entrapments were found - Low risk.

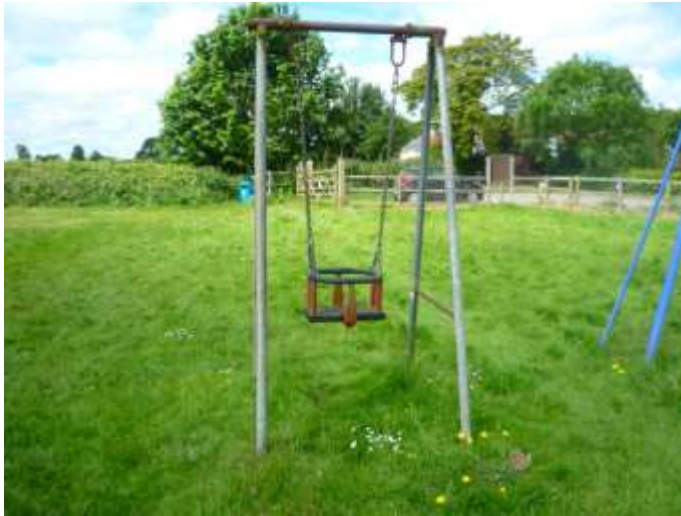
Item: 1 Bay 1 Cradle Seat Swing (2200mm) – Self Made

The item fails to meet the requirements of EN1176 in the following respects:

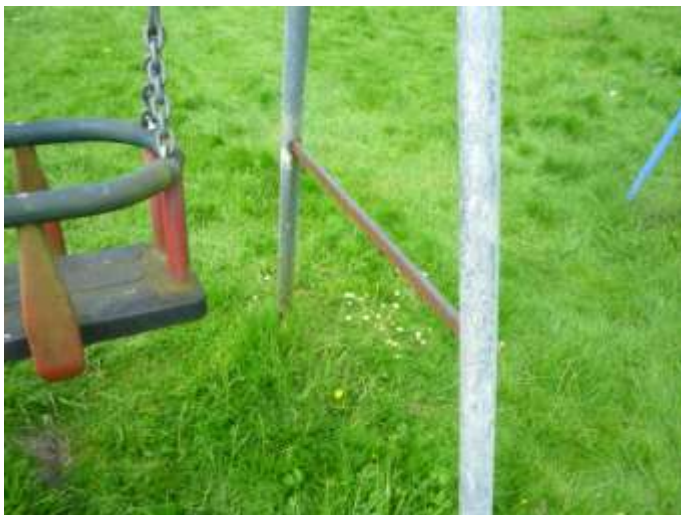
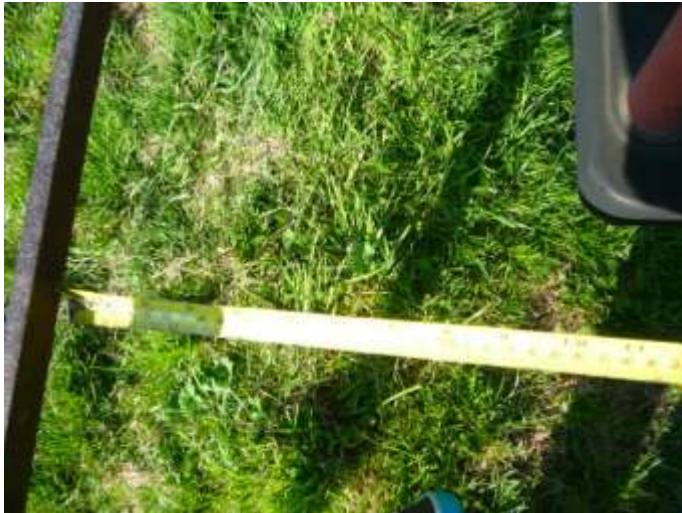
Seat situated too close to supports – Recommend Monitor only – Low risk.

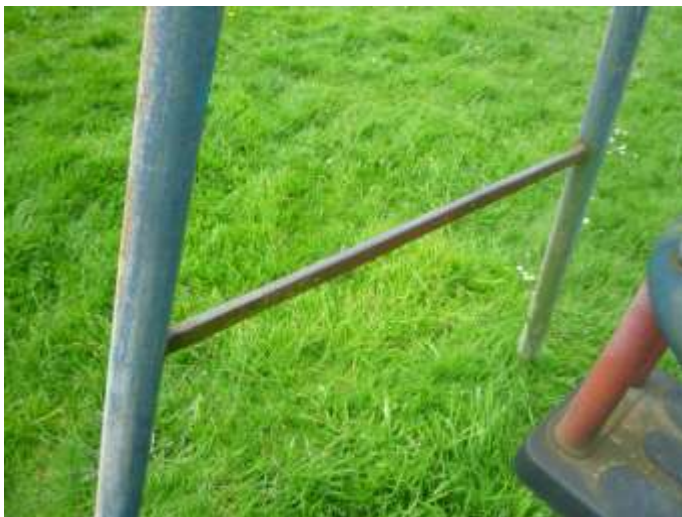
Swing frame bars are climbable – Recommend monitor - Low risk.

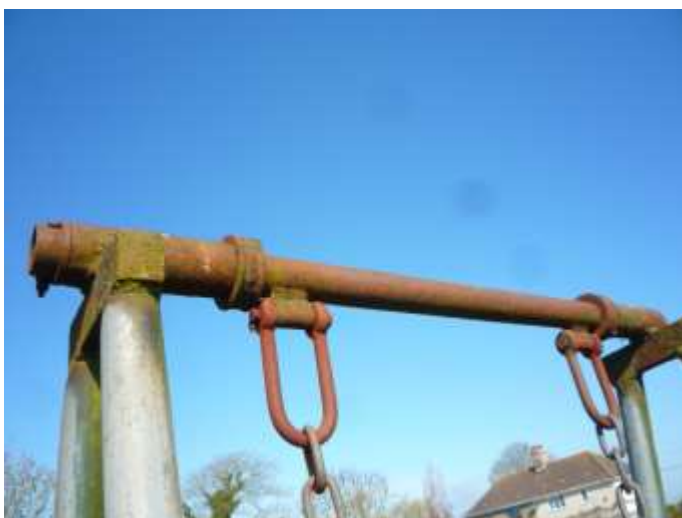
Recommend lubricate shackles at top bar – noisy – Low risk.

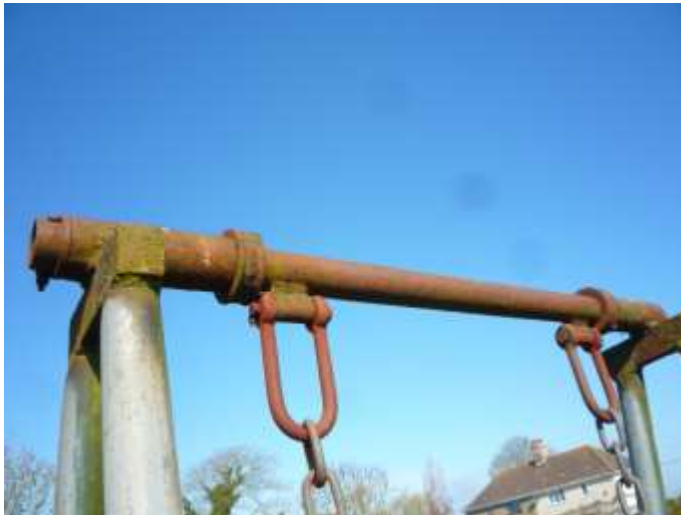
Top Bar - Recommend rub down and remove rust and flaking paint, which has rough and sharp areas - and repaint to prolong life of item - Low risk.

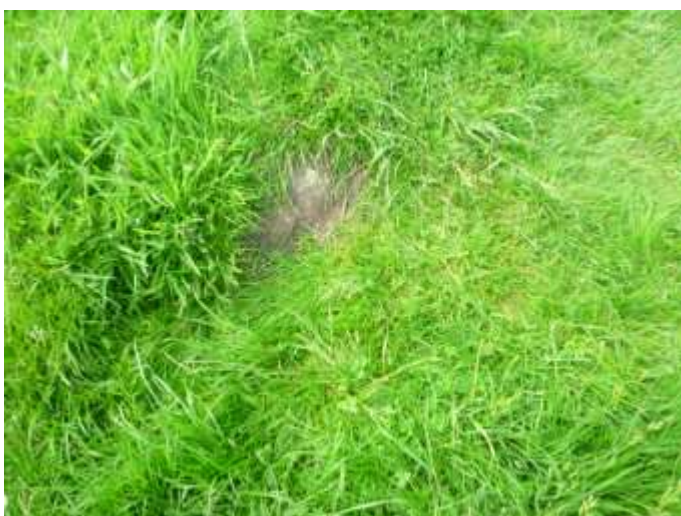
Recommend infill worn and uneven area – Low to Medium risk.

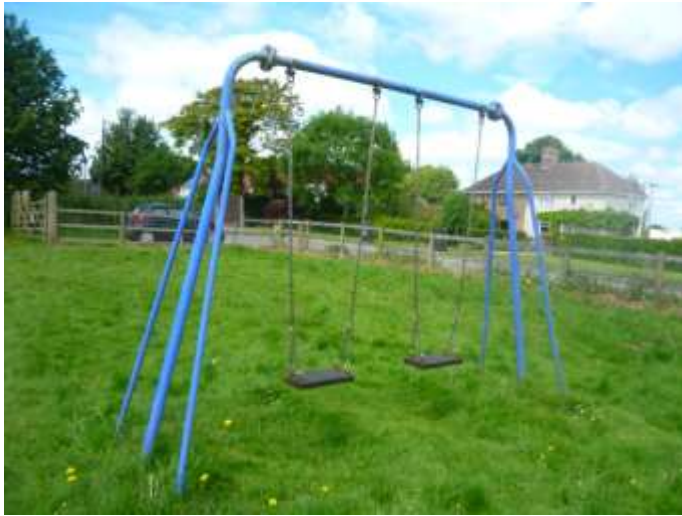
Item: 1 Bay 2 Flat Seat Swing (2300mm) – Wicksteed Leisure

The item meets the requirements of EN1176 where this may be tested on site without dismantling or destruction.

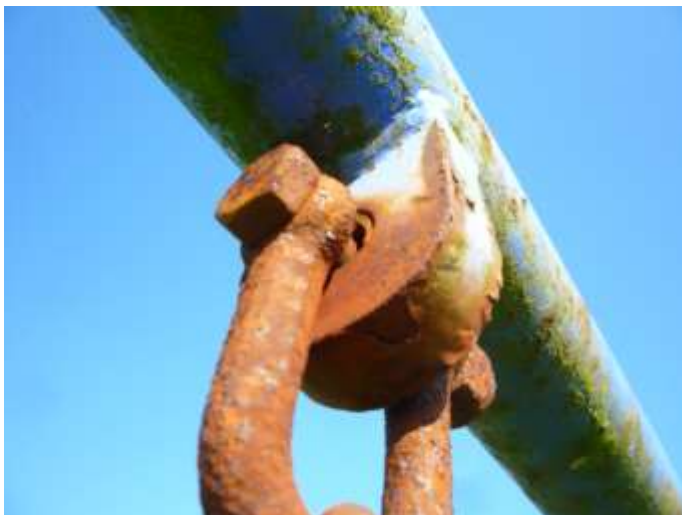
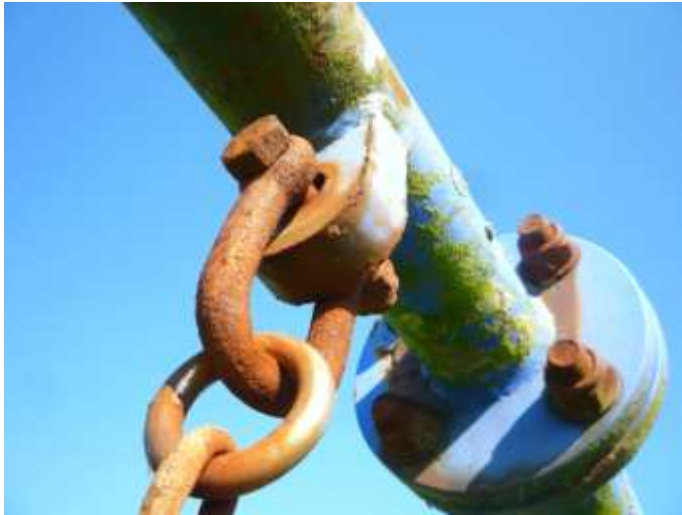
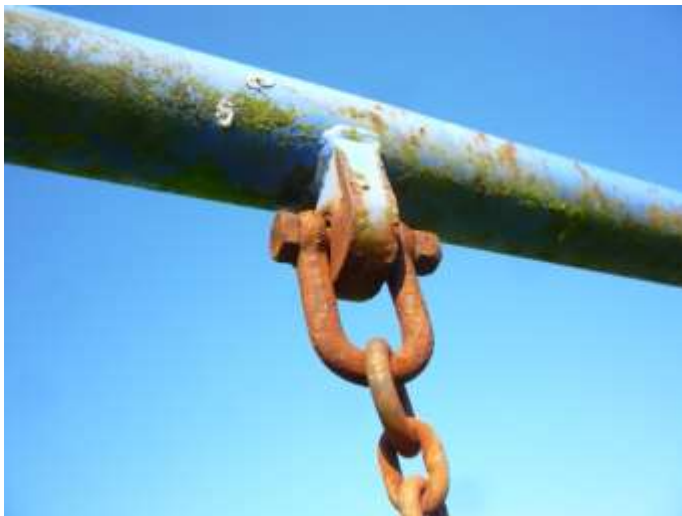
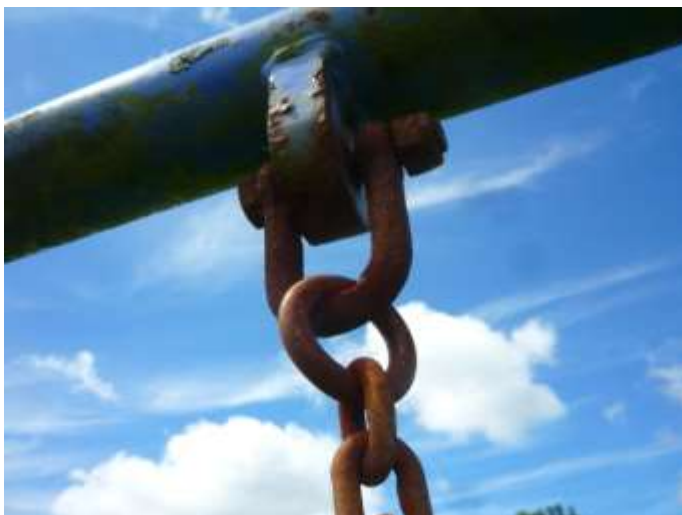
Recommend replace all worn and missing bushes and replace all rusty shackles and bolts at the same time (x 4) – Low risk.

Recommend rub down and remove rust and flaking paint, which has rough and sharp areas - and repaint to prolong life of item - Low risk.

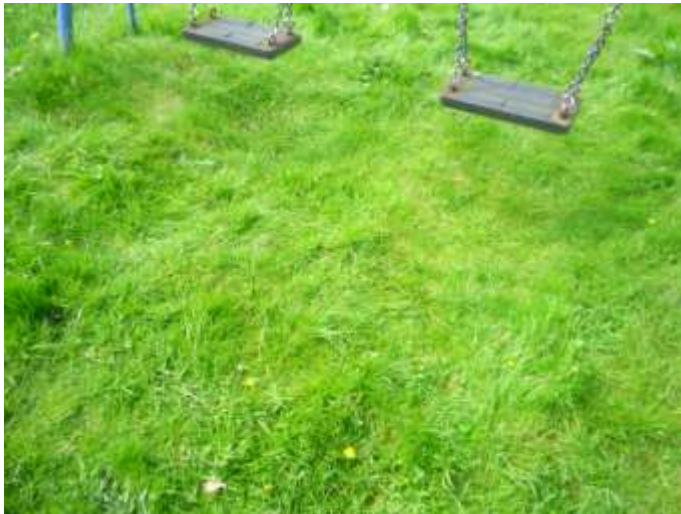
A surface other than grass is required for this item as fall height in in excess of 1500mm - Recommend provide surface to conform to EN1176 – Low to Medium risk.

Recommend infill uneven areas - Low to Medium risk.

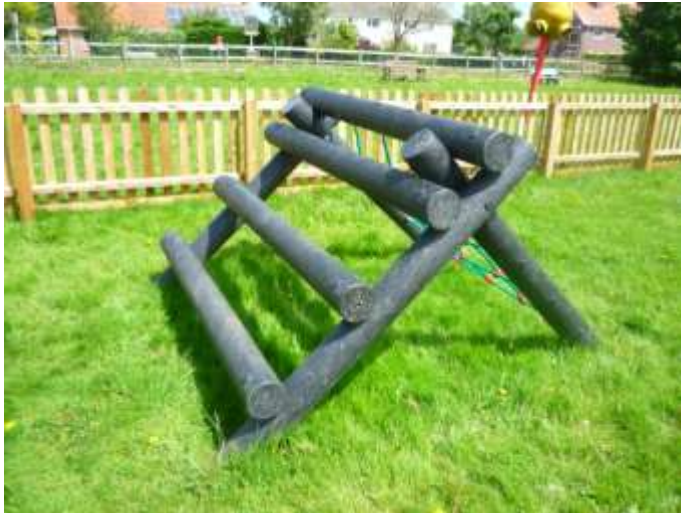
Item: A Frame Climber – Play Quip

The item meets the requirements of EN1176 where this may be tested on site without dismantling or destruction.

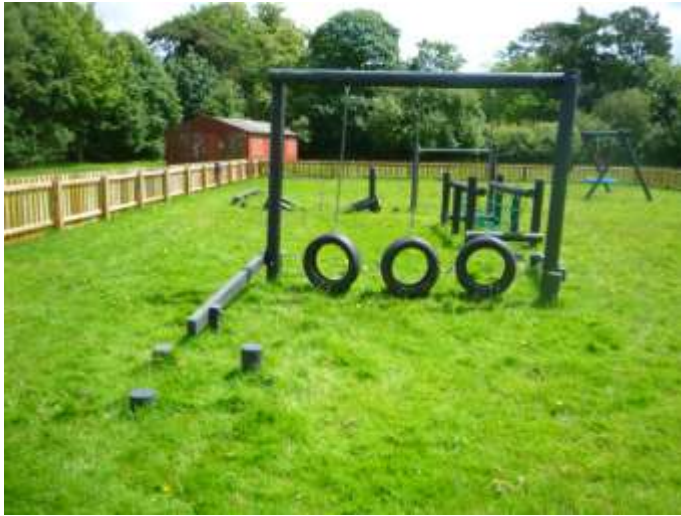
Item: Beams with Tyre Traverse and Step Posts x 5 – Play Quip

The item meets the requirements of EN1176 where this may be tested on site without dismantling or destruction.

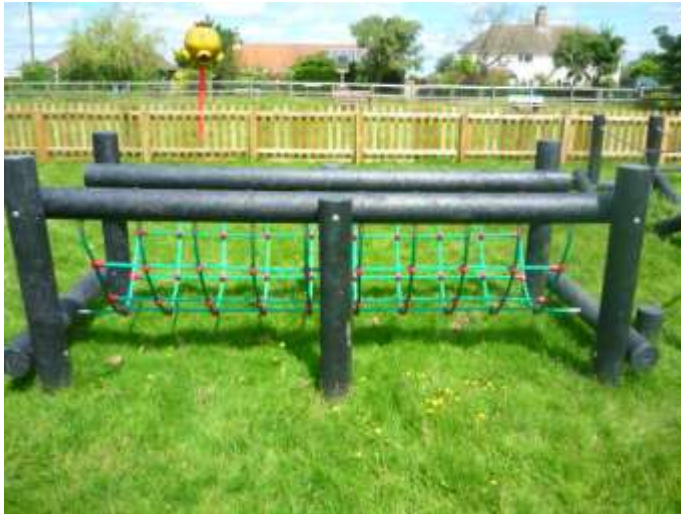
Item: Rope/Net Bridge with Step Post x 1 – Play Quip

The item meets the requirements of EN1176 where this may be tested on site without dismantling or destruction.

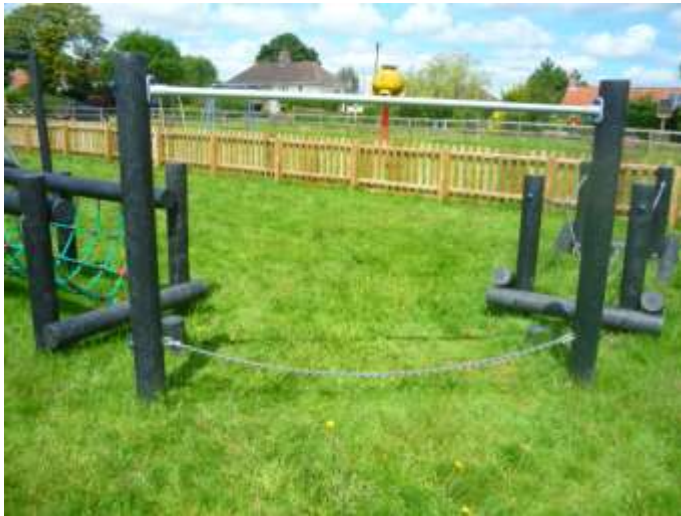
Item: Chain Traverse – Play Quip

The item meets the requirements of EN1176 where this may be tested on site without dismantling or destruction.

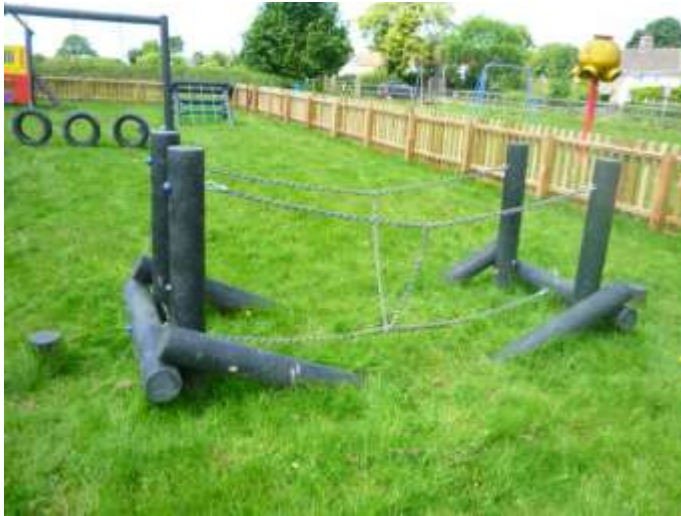
Item: Burma Bridge with Step Posts x 2 – Play Quip

The item meets the requirements of EN1176 where this may be tested on site without dismantling or destruction.

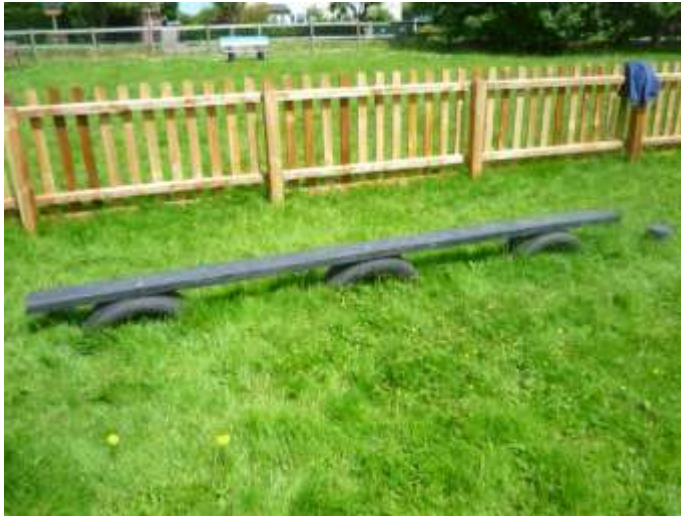
Item: Beam on Tyres with Step Posts x 2 – Play Quip

The item meets the requirements of EN1176 where this may be tested on site without dismantling or destruction.

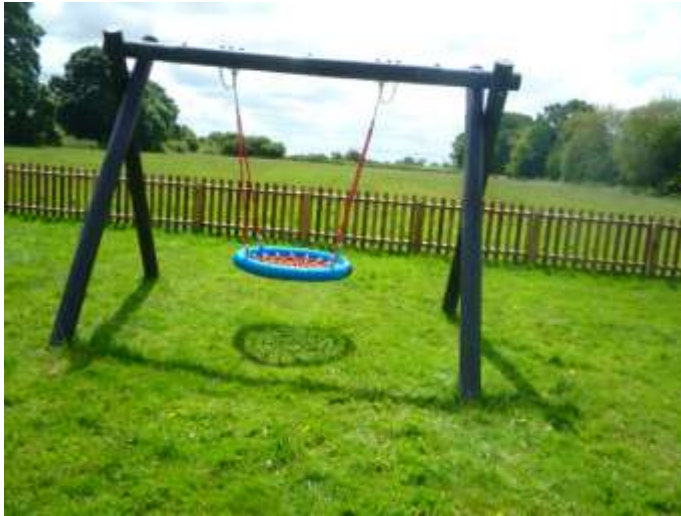
Item: Basket Swing (2100mm) – Play Quip

The item meets the requirements of EN1176 where this may be tested on site without dismantling or destruction.

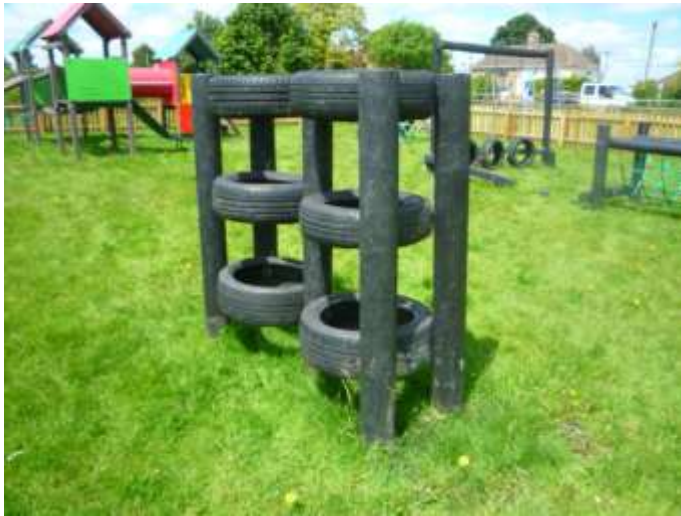
Item: Tyre Climber – Play Quip

The item meets the requirements of EN1176 where this may be tested on site without dismantling or destruction.
